# Environmental Assessment and Preparation of Environmental Management Framework for Rashtriya Madhyamik Shiksha Abhiyan (RMSA)

**Government of India  
Ministry of Human Resource Development  
Department of School Education & Literacy**

**SENES Consultants India Pvt. Ltd.**

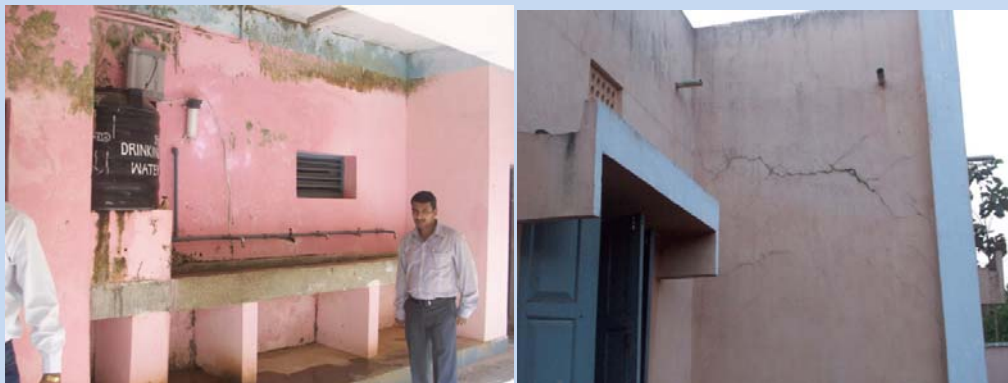
*The above pictures damp affecting electrical wiring at Jawahar Navodaya Vidyalaya and cracks hostel building of Government Girls High School (Girls), Dutipada respectively*

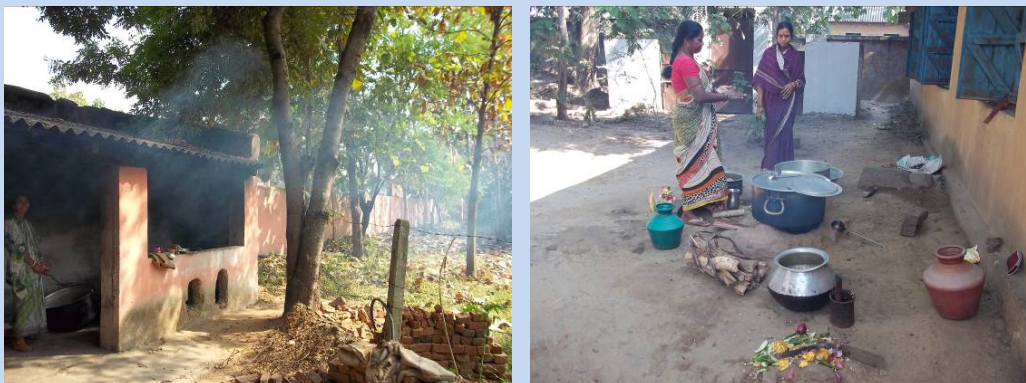
*The picture at the left shows dedicated kitchen with proper shade, while the picture at the right shows open kitchen facilities in the school*

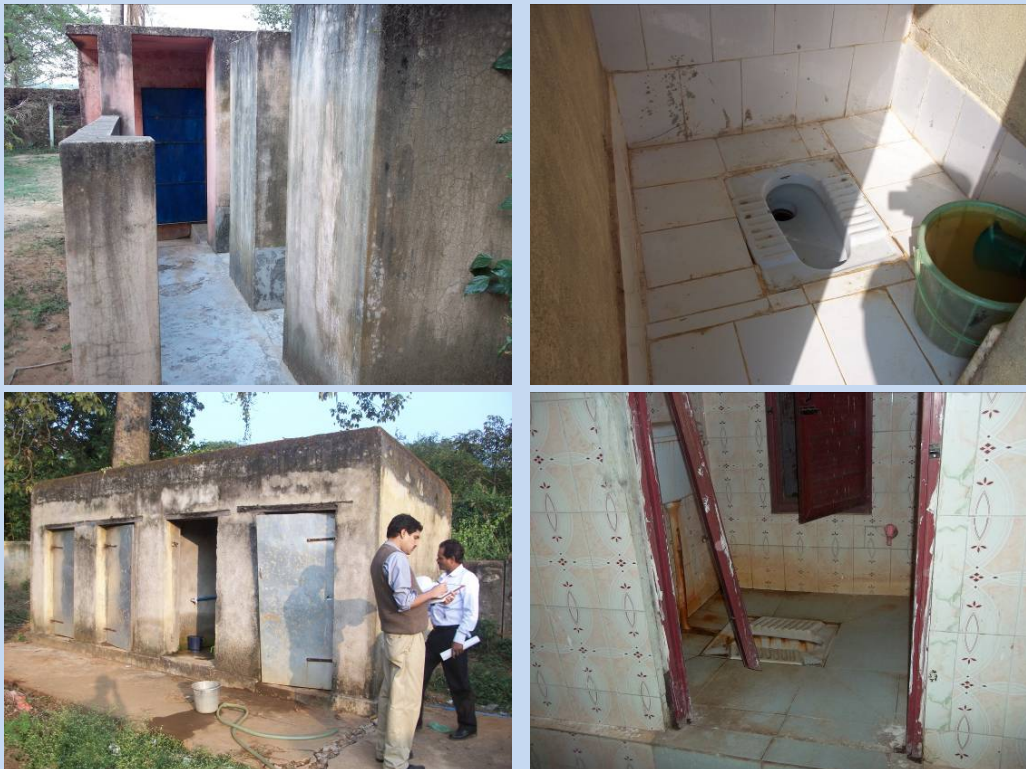
*The scoring of sanitation facilities was done looking into the structural condition, hygiene, water connection, separate facility for girl students and for teachers. The above two picture shows good sanitation facilities in terms of structural condition and hygiene which were taken as benchmark. The two pictures below average and poor structural conditional respectively.*

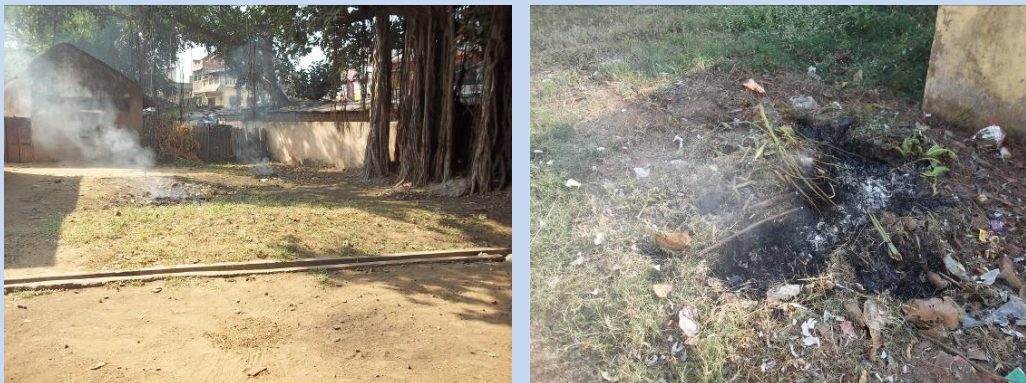
*Burning of waste in the schools of the Orissa*

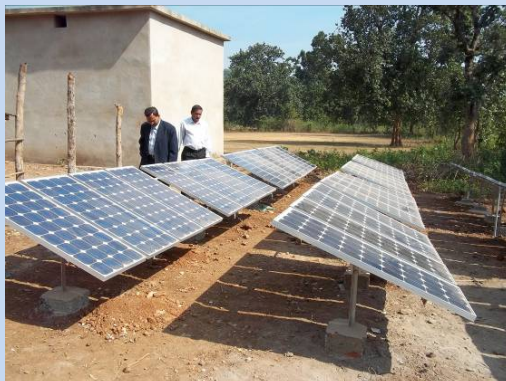
*Installation of solar panels under Rural electrification Scheme at Kichinda UPS*

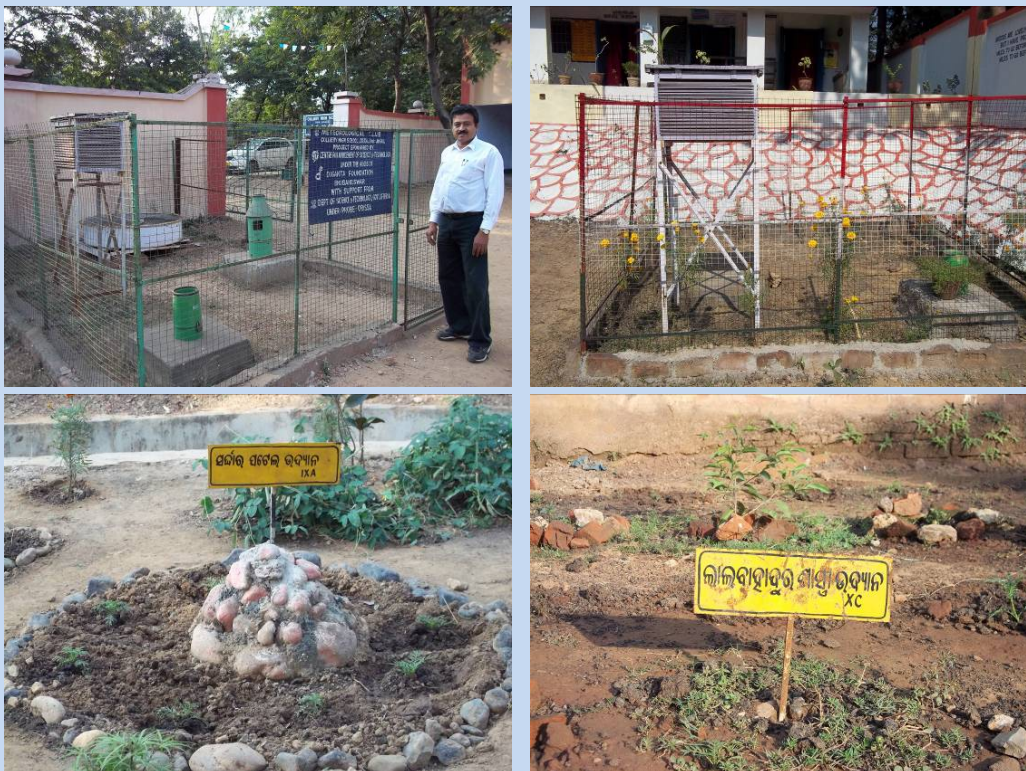
The above two pictures shows Meterological Station at Talcher High School and Kuarmunda Girls High School. The pictures below shows the demarcation of the school area under different classes at Uditnagar Government High School

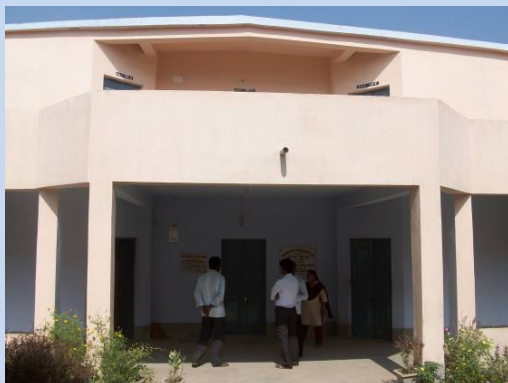
*Cyclone shelter in one of the schools in the coastal districts*

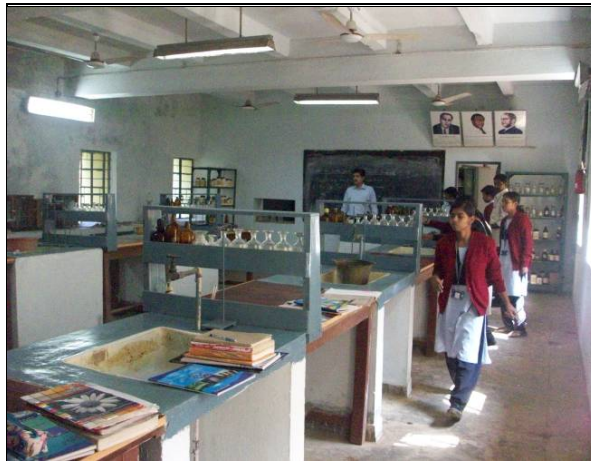
*Laboratory with running water facilities, proper height tables and sufficient movement space*

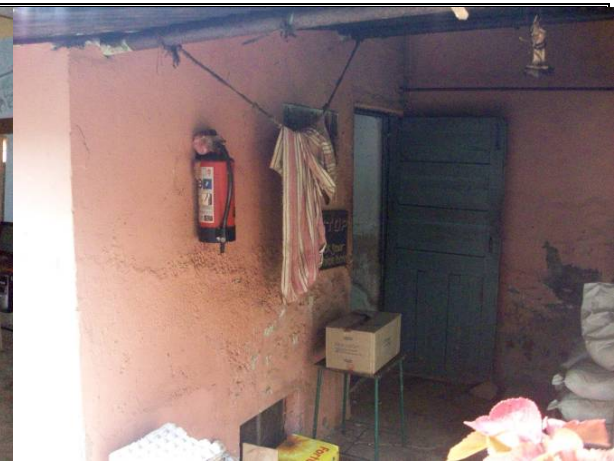
*Fire extinguisher outside LPG store room*

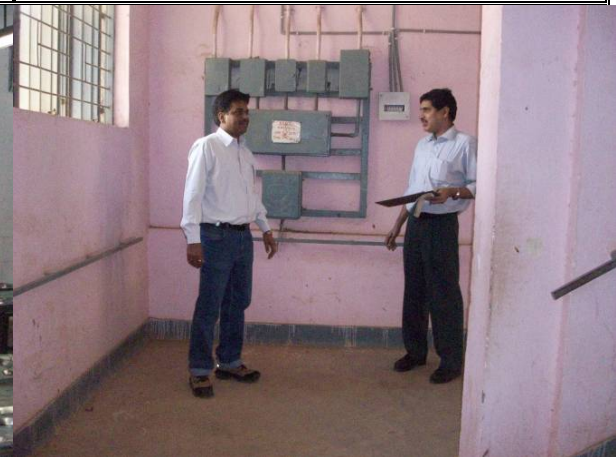
*Main switch at very low height behind the staircase*
